## ***ENGINEERING REPORT***

### **FAA CONTRACT NO. DTFA03-02-C-00044 PHASE 1, CLIN 0001f (TASK 6) - PRE-TEARDOWN INSPECTION REPORT**

This report supports Task 6 of FAA Contract No. DTFA03-02-C-00044. Various NDT and visual inspections were accomplished on panels which were removed from aircraft N474DA, a Boeing 727-232. The pre-teardown inspections were conducted after aircraft disassembly and prior to teardown and destructive testing. This report provides details and results of the inspections, including procedures used, locations and documentation of defect indications noted, detailed fastener parameters, condition of the panels after aircraft disassembly, and a comparison of the Field Inspections previously accomplished.

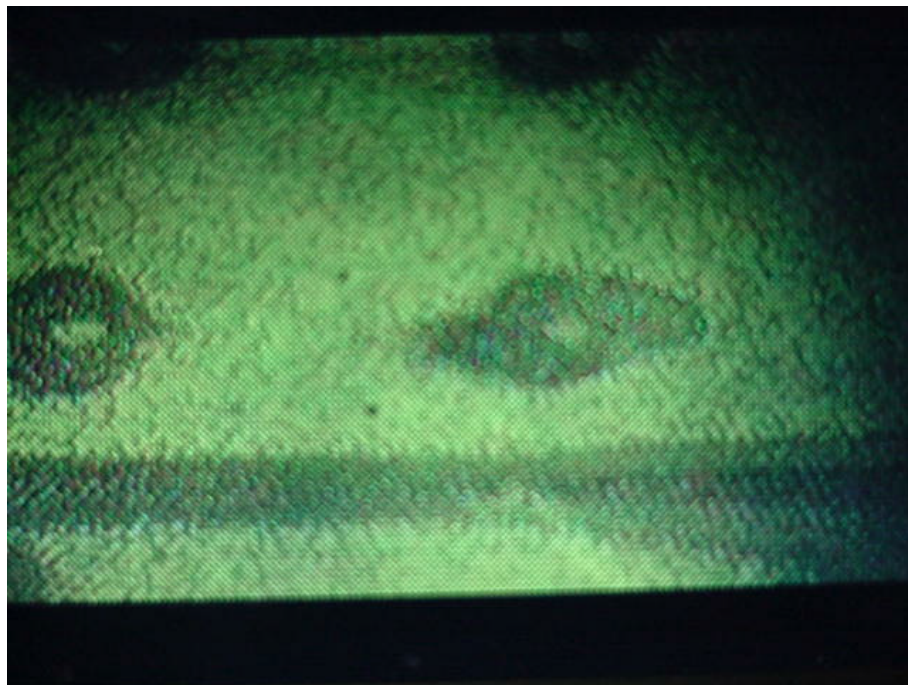
Figure 51. Screen representation of MOI indication at rivet #14 between BS 520 and BS 540 on the lower row of the longitudinal lap joint at stringer 4R.

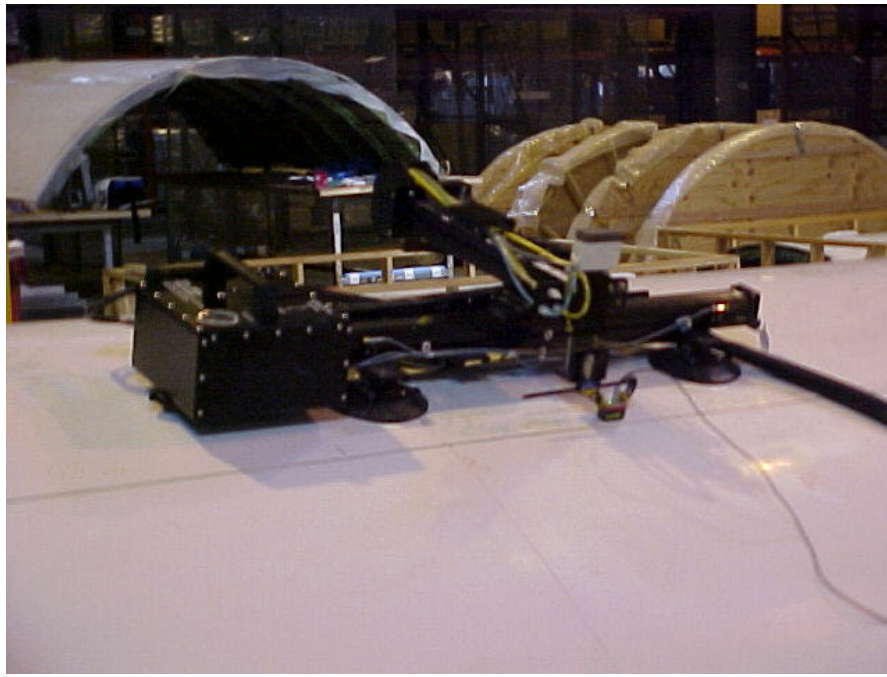
The C-scan eddy current had indications, which are shown in Table 29. Twelve indications were found on the lower row of fasteners on stringer 4R. No indications were found on stringer 4L. Figure 52 shows a photograph of the inspection being conducted, and Figure 53 shows screen representations of the signals. Additional screen representations and photographs can be found in Appendix G.

Figure 52. Photograph of the C-scan Eddy Current inspection being conducted.

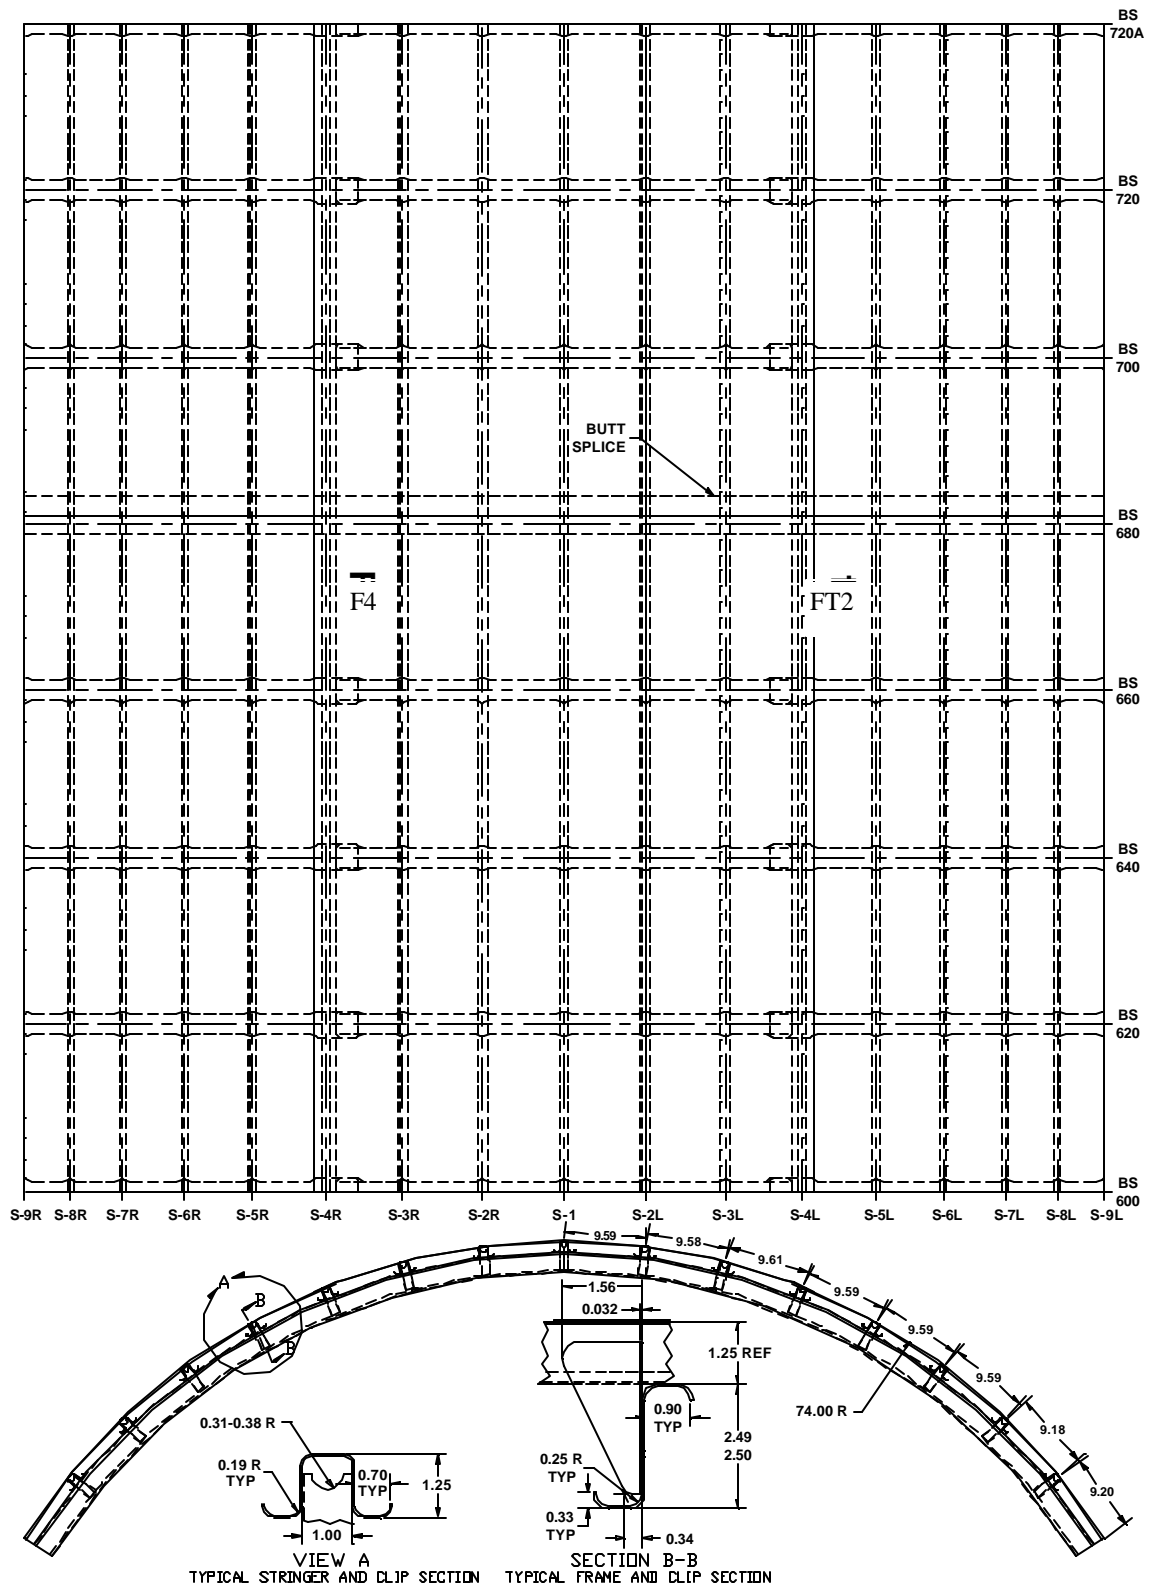
Figure 54. Engineering drawing of panel FT2/F4.

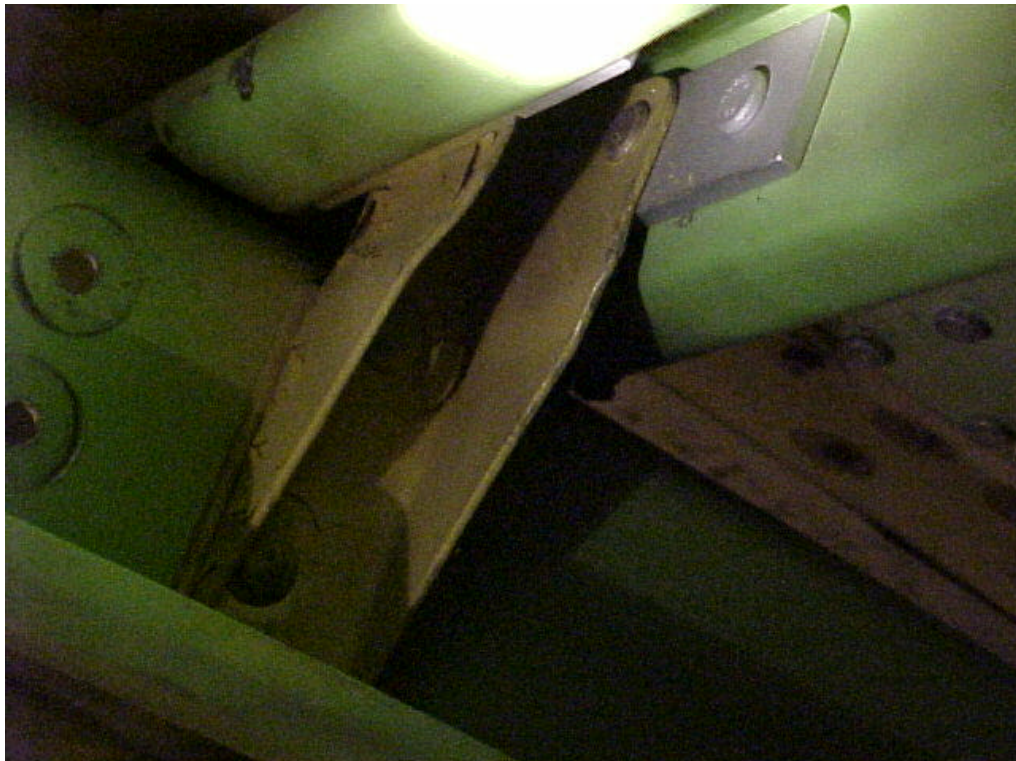
Figure 56. Photograph showing replacement stringer clip.

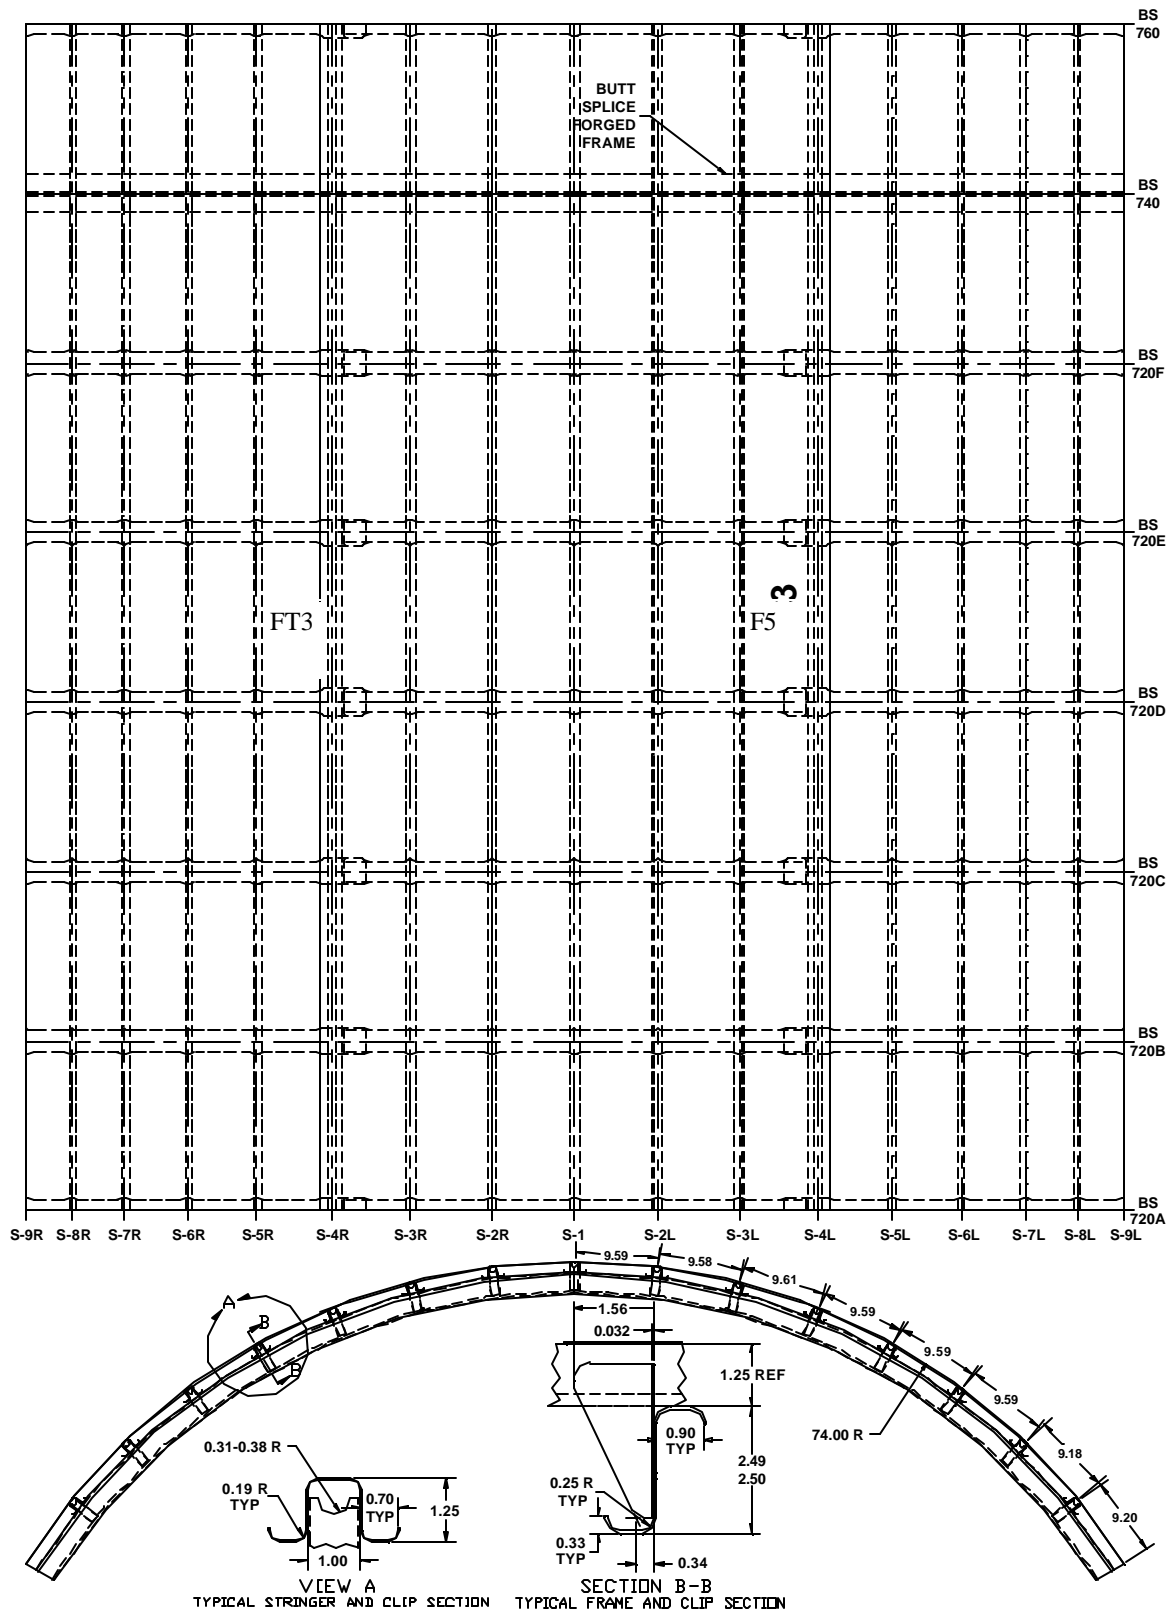
Figure 57. Engineering drawing of panel FT3/F5.

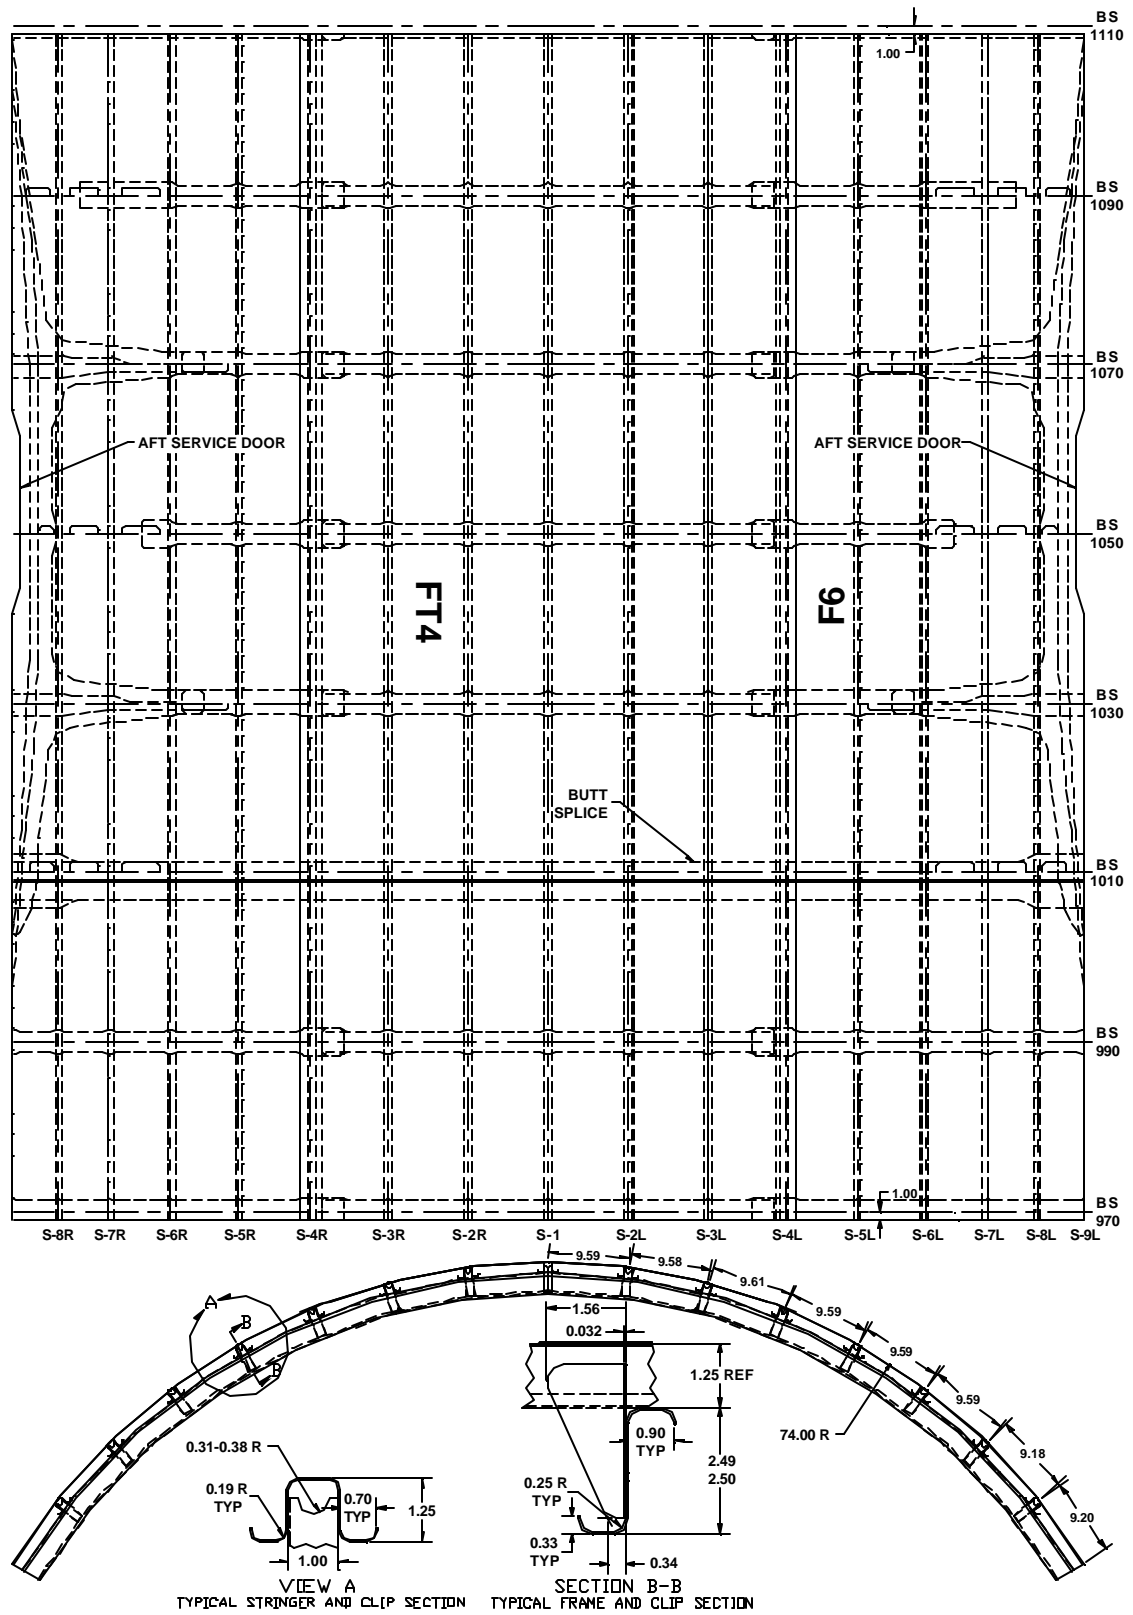
Figure 58. Engineering drawing of panel FT4/F6.

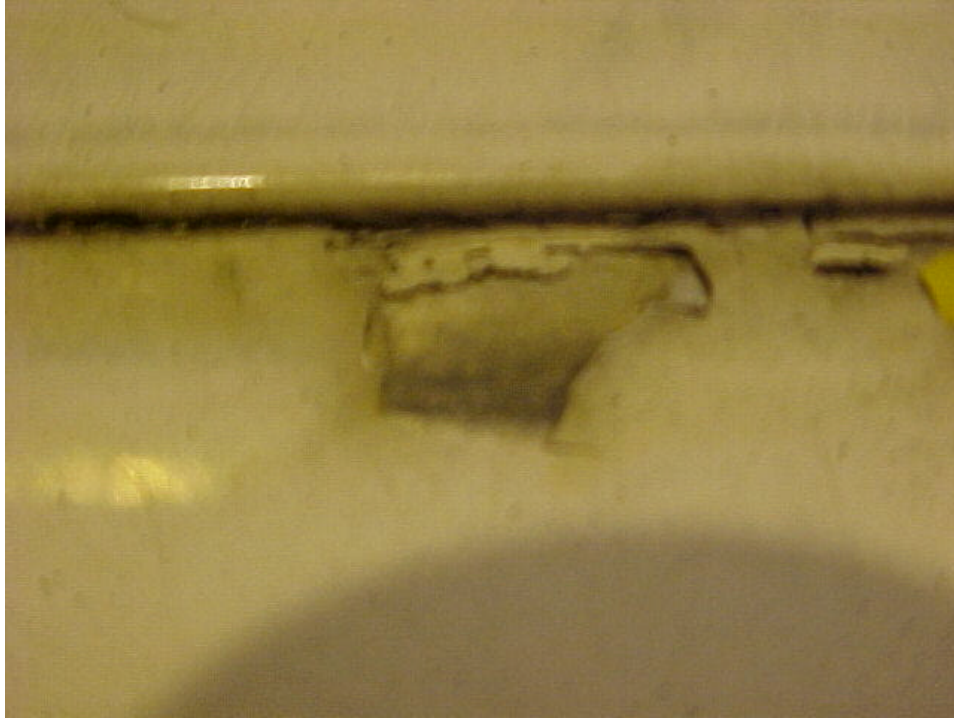
Figure D-1. Photograph showing paint flaking at BS 360 +4'', on stringer 4L (panel F1).

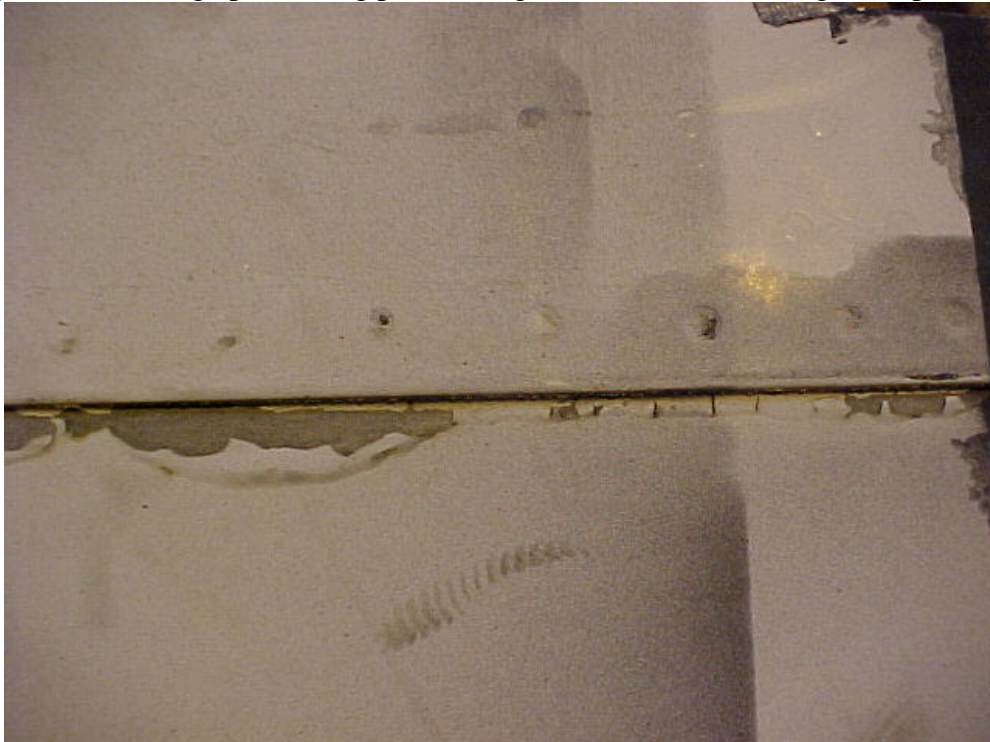
Figure D-2. Photograph showing paint flaking near BS 970 on stringer 4L (panel F2).

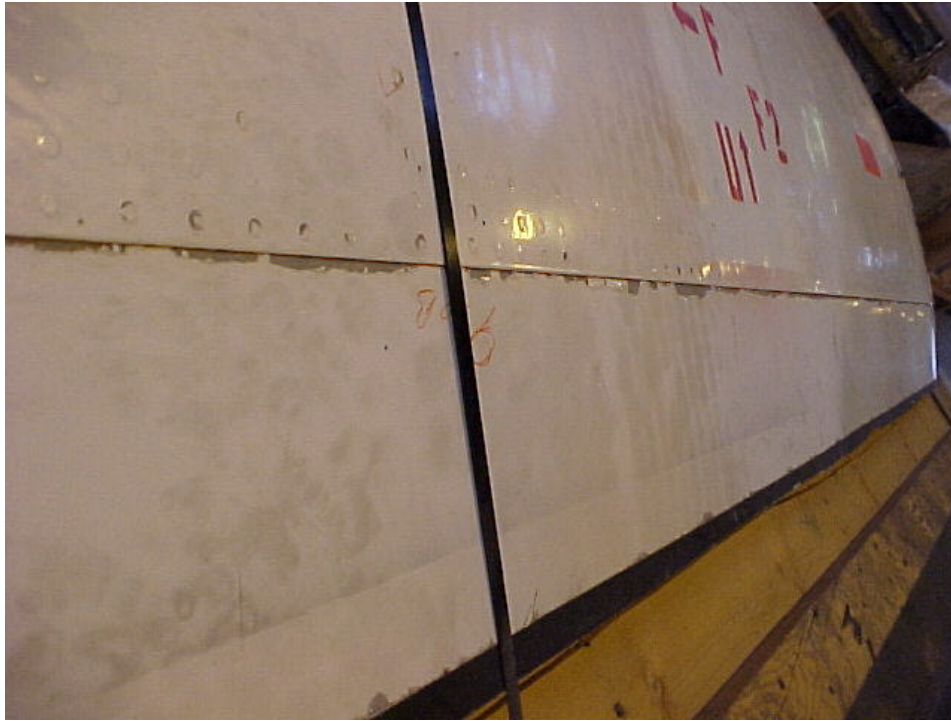
Figure D-3. Photograph showing general paint flaking along stringer 4L (panel F2).

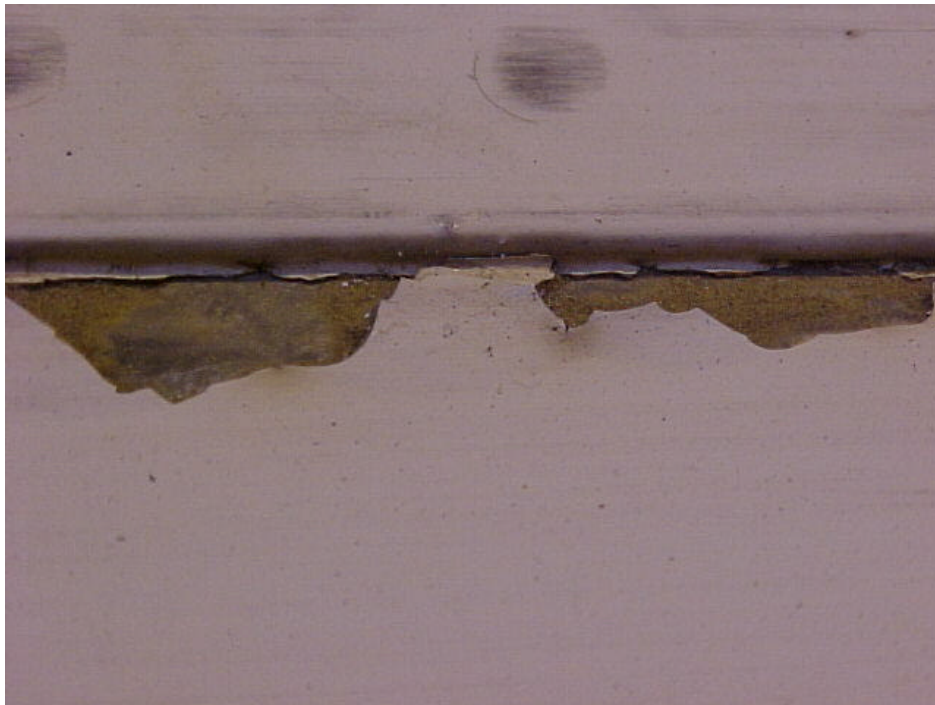
Figure D-4. Photograph showing general paint flaking and some corrosion along stringer 4R near BS 580 -3'' (panel FT1/F3).

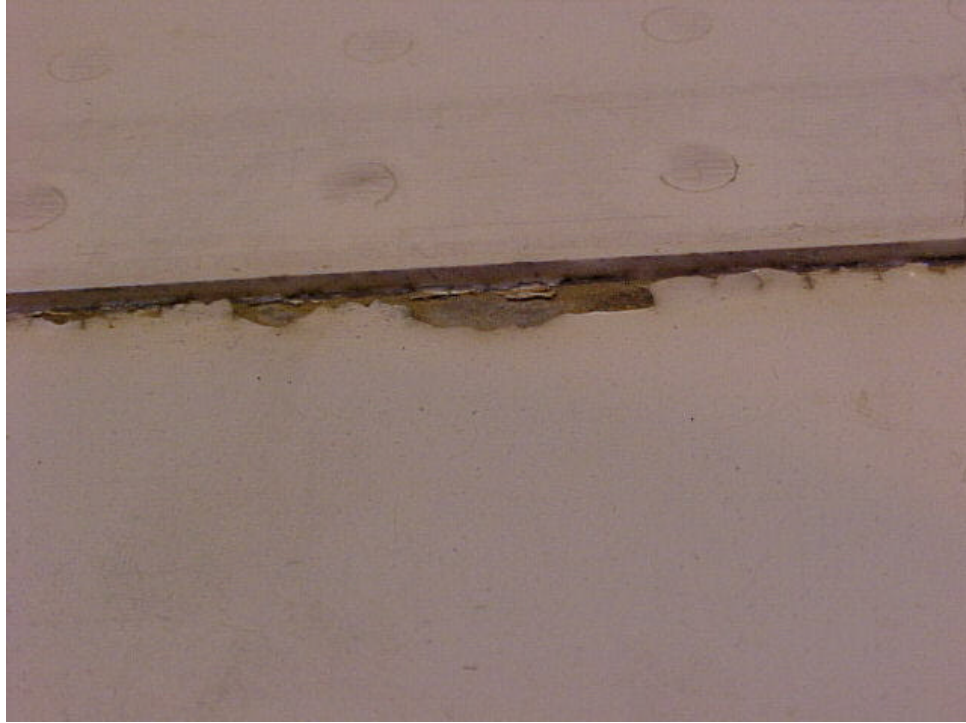
Figure D-5. Photograph showing general paint flaking and some corrosion along stringer 4R near BS 530 +10'' (panel FT1/F3).

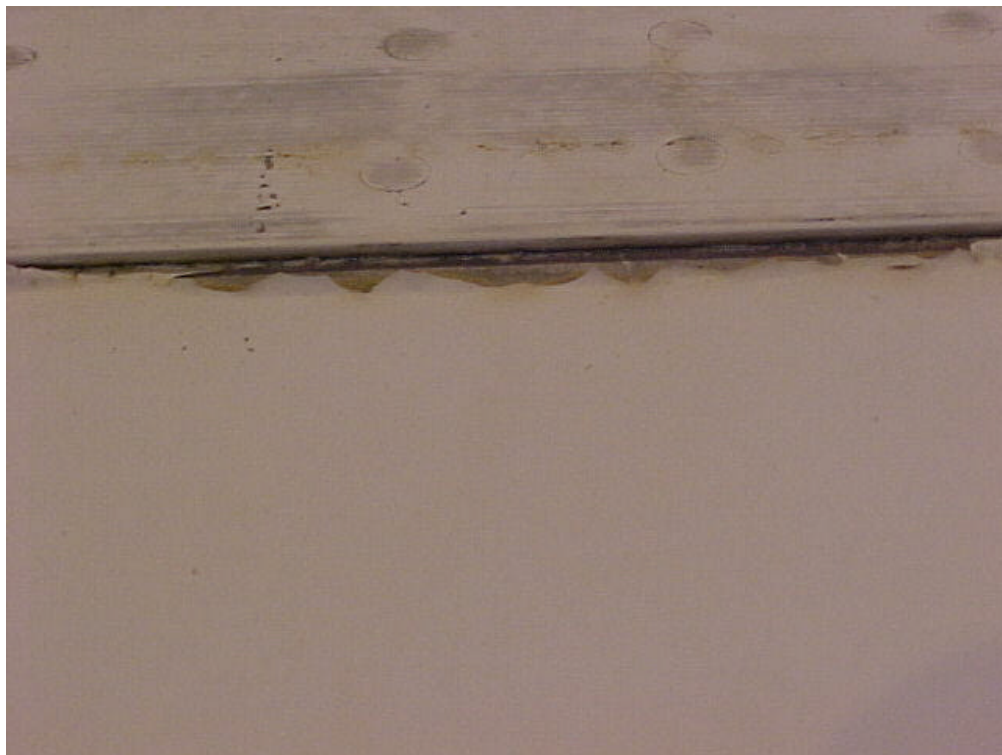
Figure D-6. Photograph showing general paint flaking and some corrosion along stringer 4R near BS 640 -5'' (panel FT2/F4).

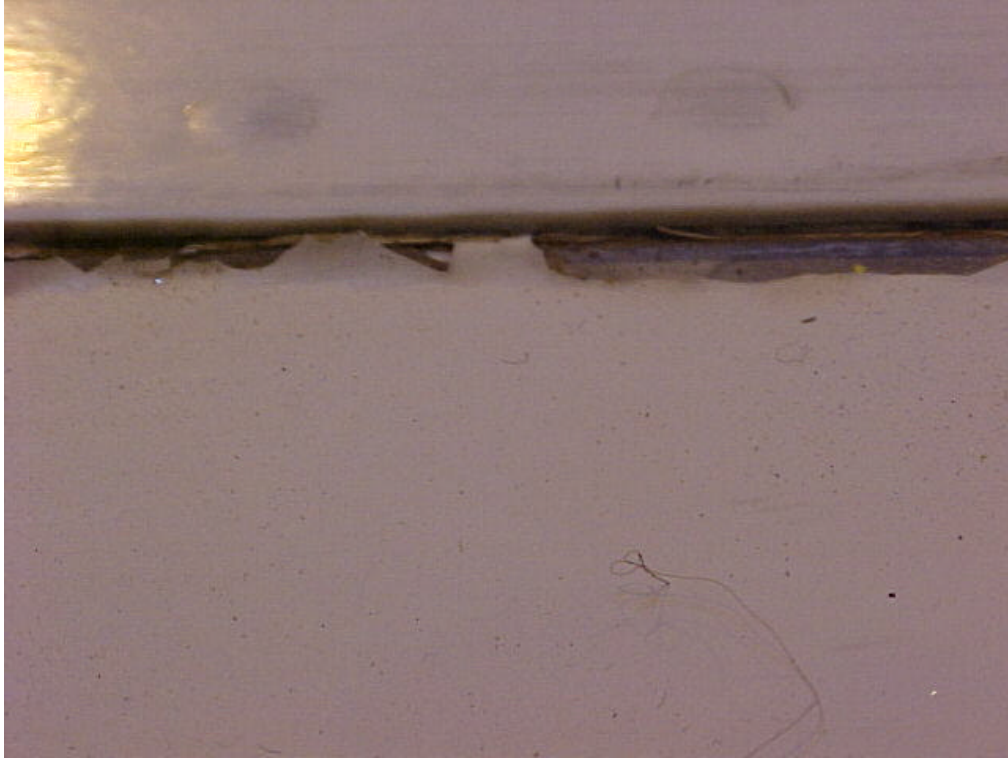
Figure D-7. Photograph showing general paint flaking and some corrosion along stringer 4R near BS 720F +5'' (panel FT3/F5).

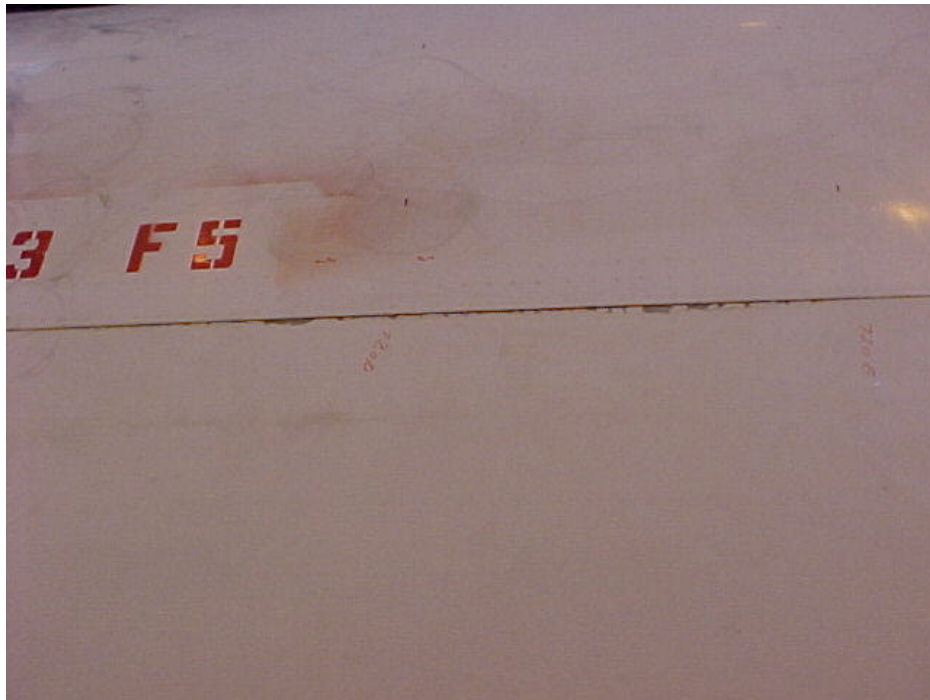
Figure D-8. Photograph showing general paint flaking and some corrosion along stringer 4L (panel FT3/F5).

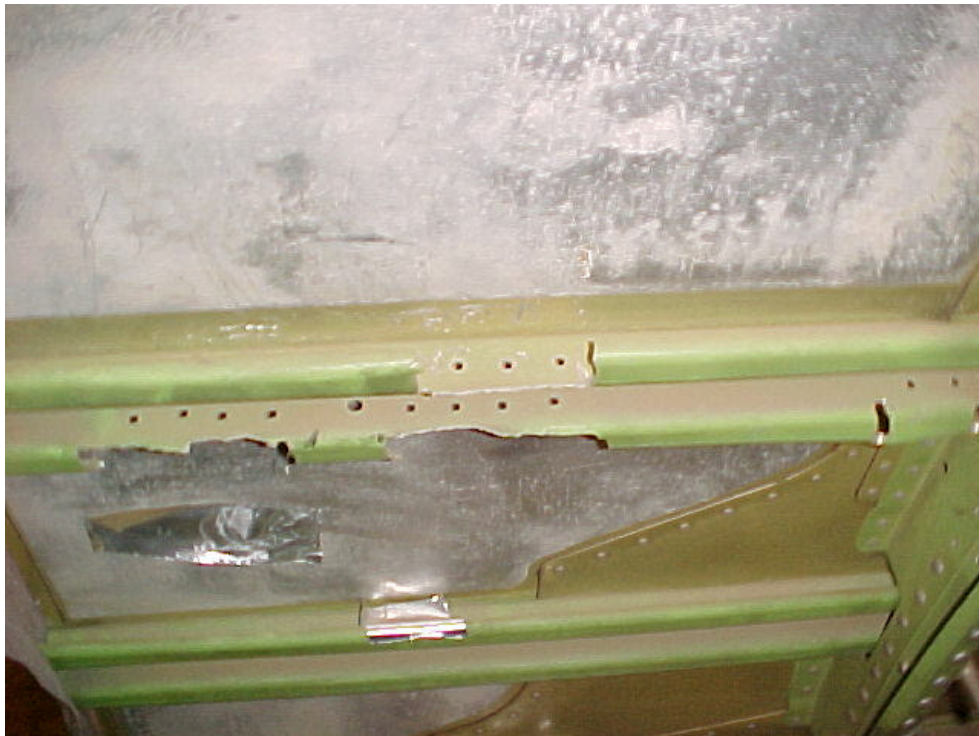
Figure D-10. Photograph showing damaged stringers 7L and 8L from BS 1070 to BS 1110 (panel FT4/F6).

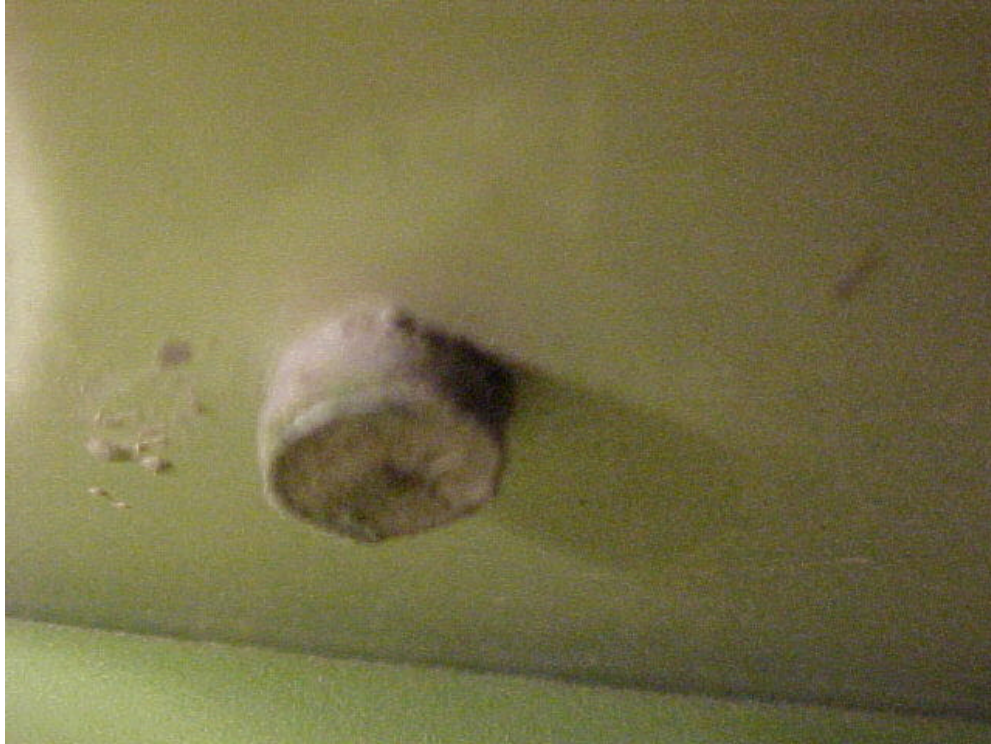
Figure D-11. Photograph showing internal detailed visual inspection indication at BS 400, stringer 4L, rivet 11 (panel F1).

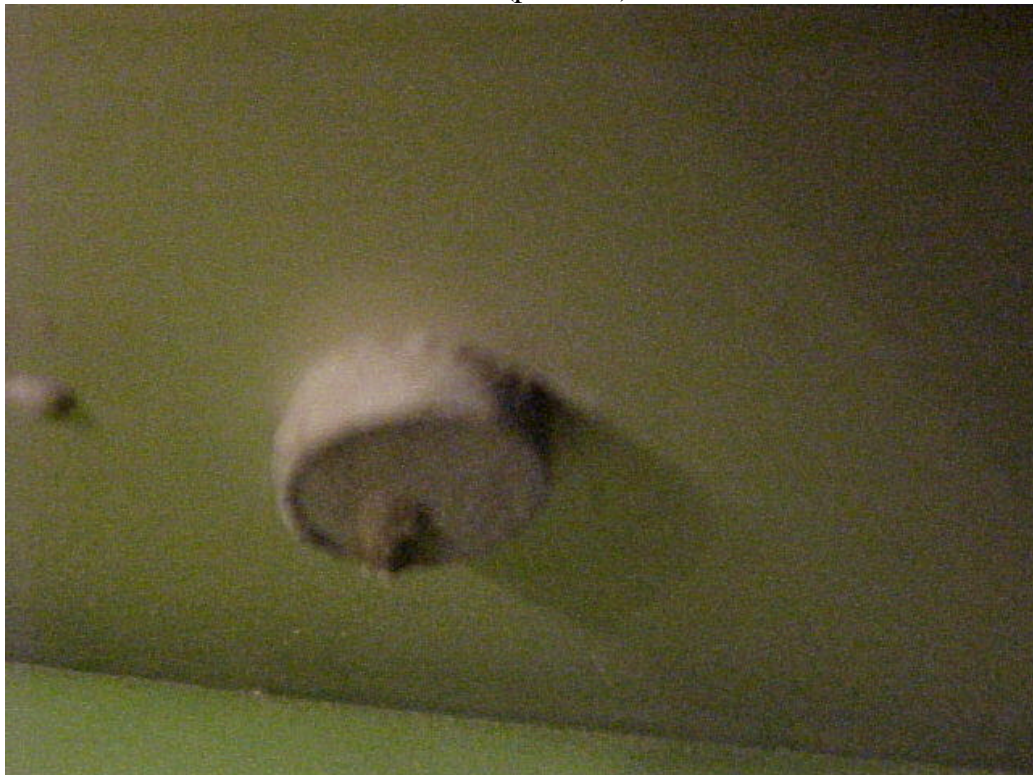
Figure D-12. Photograph showing internal detailed visual inspection indication at BS 400, stringer 4L, rivet 15 (panel F1).

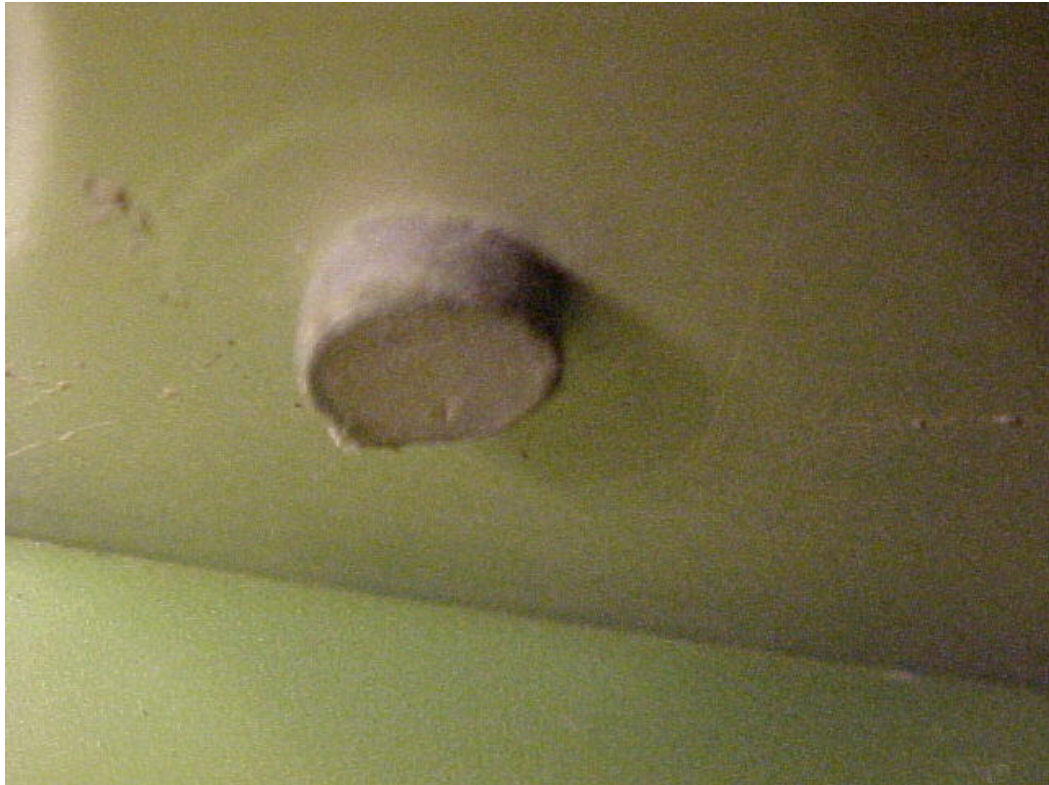
Figure D-13. Photograph showing internal detailed visual inspection indication at BS 420, stringer 4L, rivet 5 (panel F1).

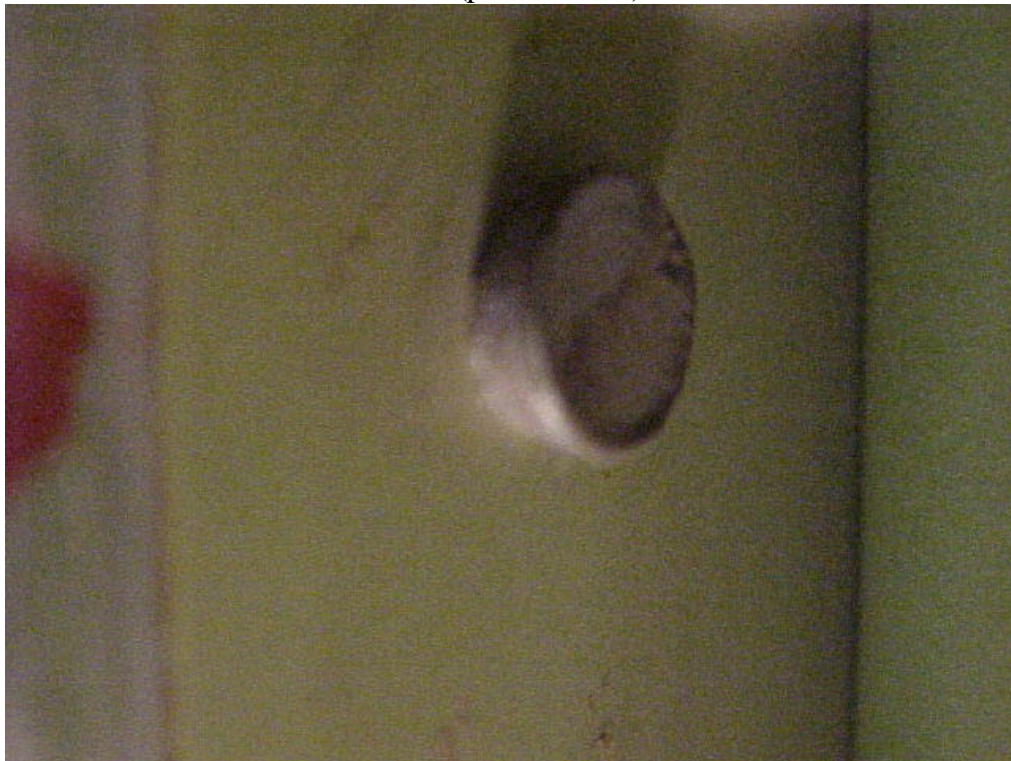
Figure D-16. Photograph showing internal detailed visual inspection indication at BS 520, stringer 4R, rivet 8 (panel FT1/F3).

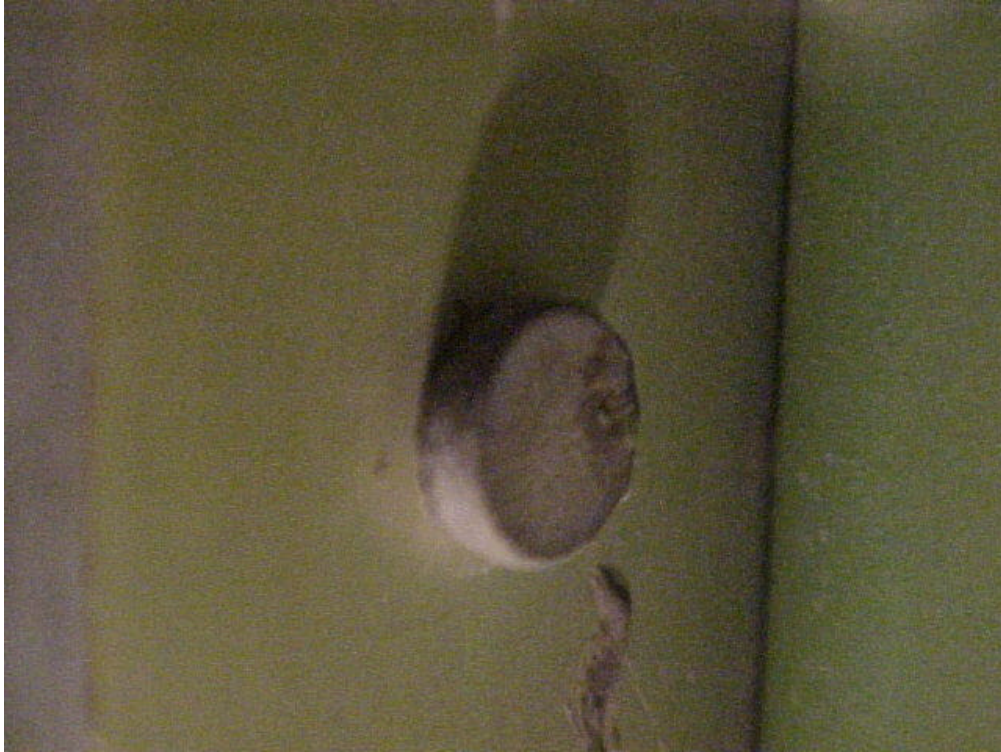
Figure D-17. Photograph showing internal detailed visual inspection indication at BS 520, stringer 4R, rivet 9 (panel FT1/F3).

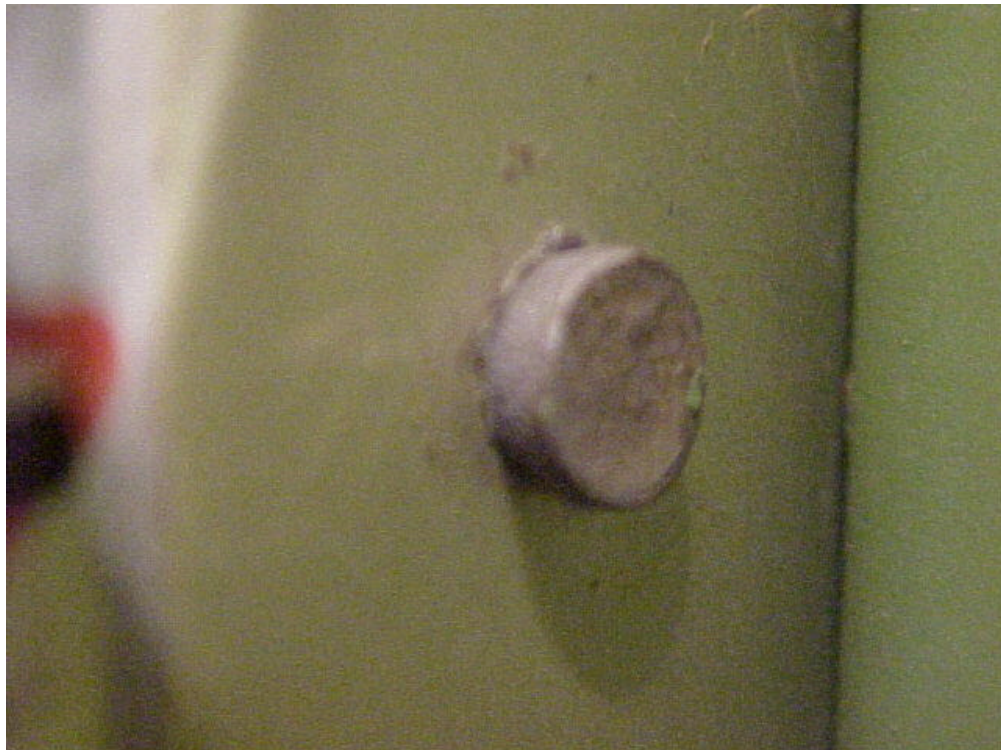
Figure D-18. Photograph showing internal detailed visual inspection indication at BS 520, stringer 4R, rivet 10 (panel FT1/F3).

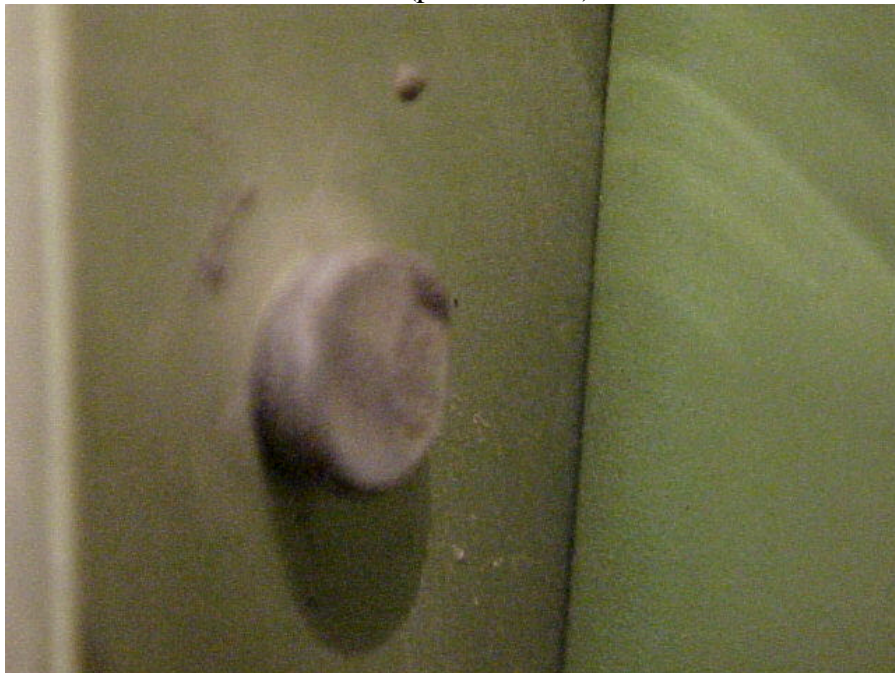
Figure D-20. Photograph showing internal detailed visual inspection indication at BS 520, stringer 4R, rivet 12 (panel FT1/F3).

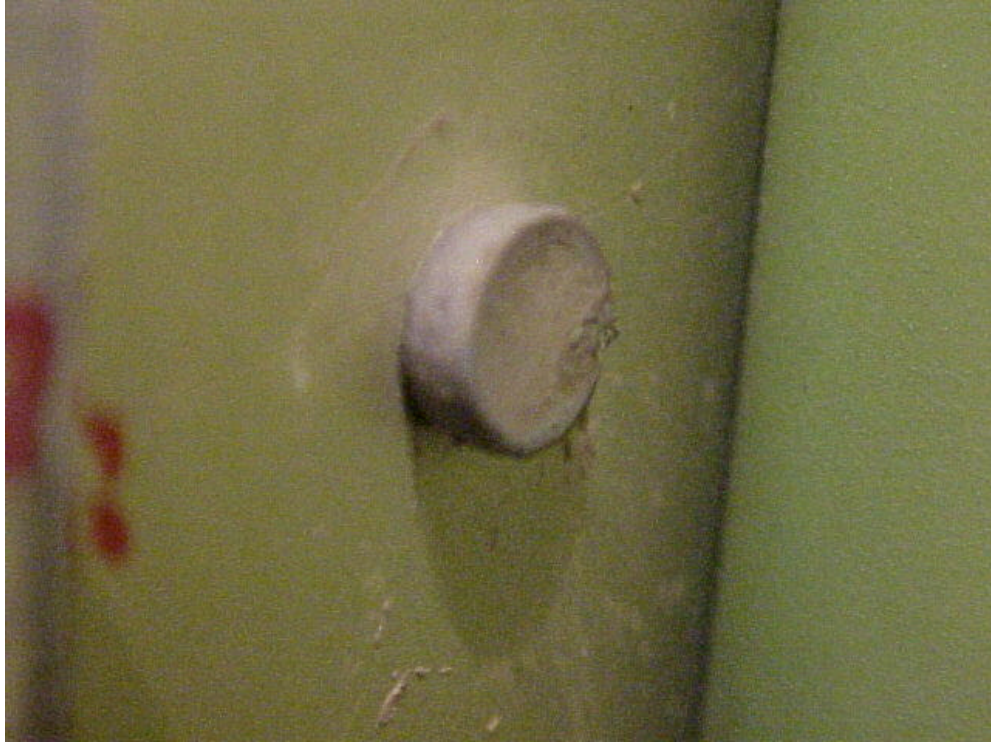
Figure D-21. Photograph showing internal detailed visual inspection indication at BS 520, stringer 4R, rivet 13 (panel FT1/F3).

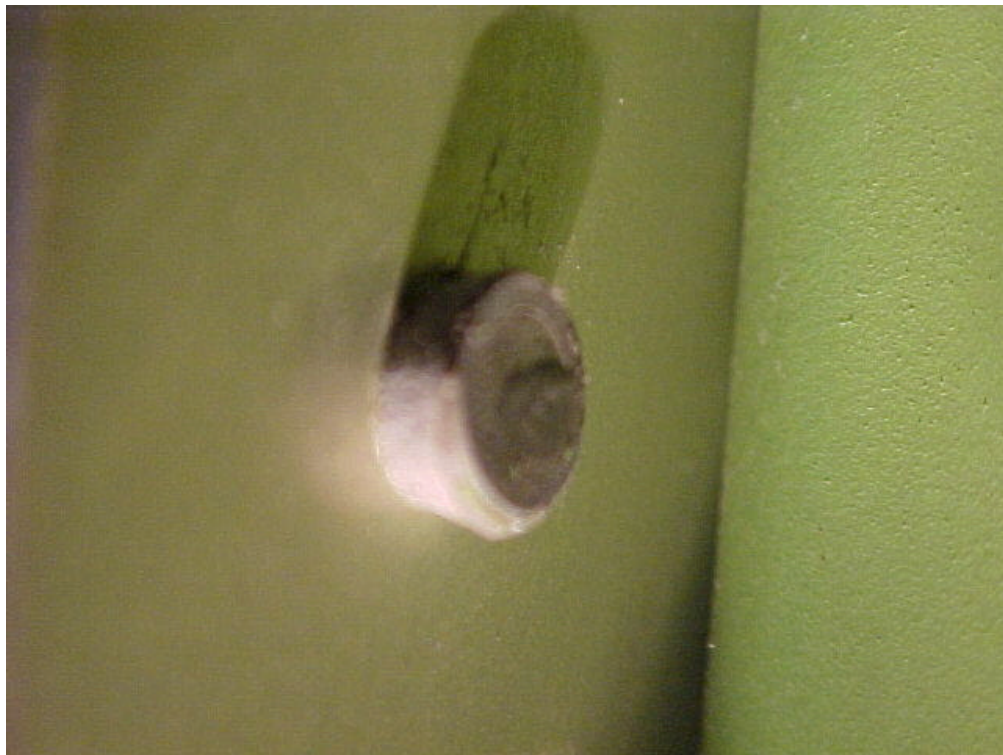
Figure D-22. Photograph showing internal detailed visual inspection indication at BS 520, stringer 4R, rivet 14 (panel FT1/F3).

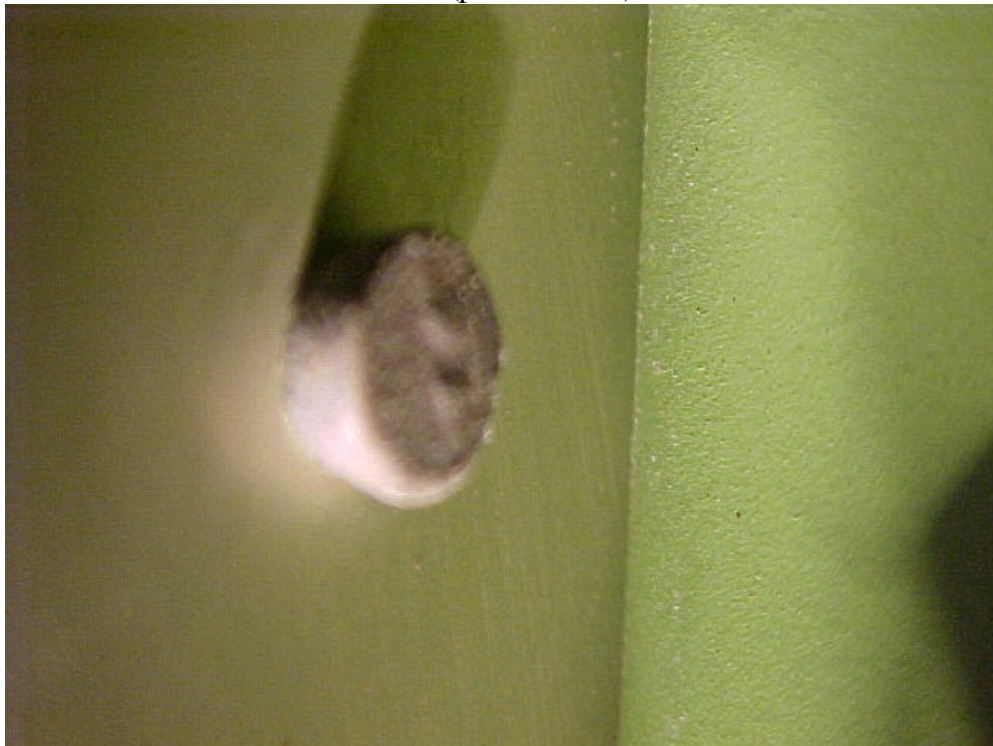
Figure D-24. Photograph showing internal detailed visual inspection indication at BS 540, stringer 4R, rivet 4 (panel FT1/F3).

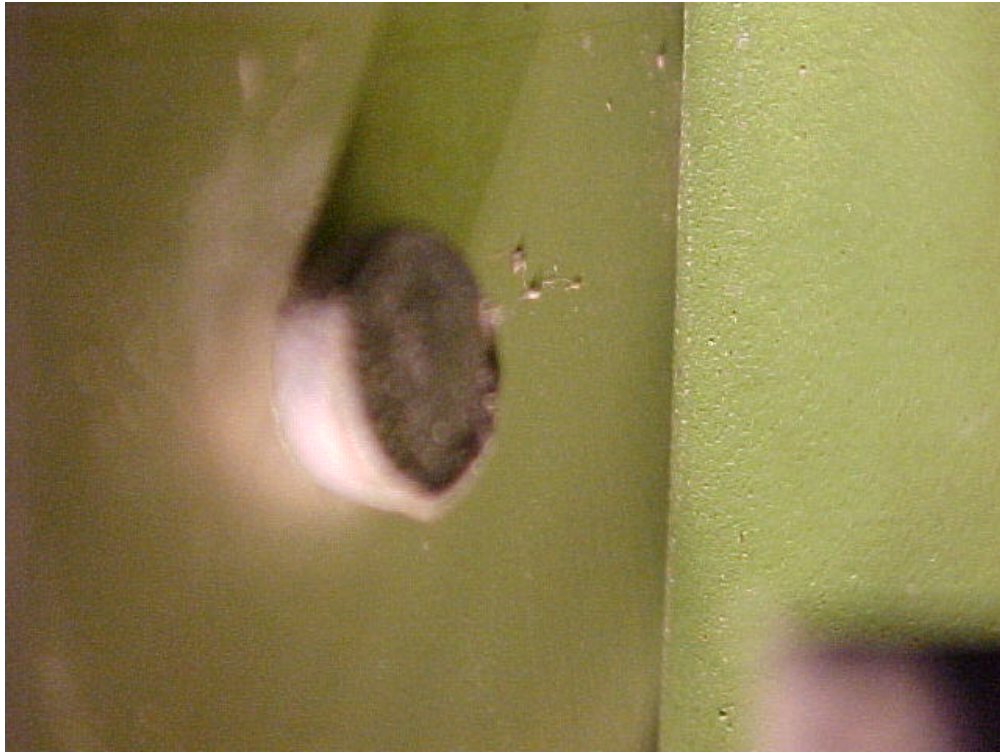
Figure D-25. Photograph showing internal detailed visual inspection indication at BS 540, stringer 4R, rivet 5 (panel FT1/F3).
